NACA RM E50C15

EFFECTS OF INLET ICING ON PERFORMANCE OF AXIAL-FLOW
TURBOJET ENGINE IN NATURAL ICING CONDITIONS

By Loren W. Acker and Kenneth S. Kleinknecht

Lewis Flight Propulsion Laboratory
Cleveland, Ohio

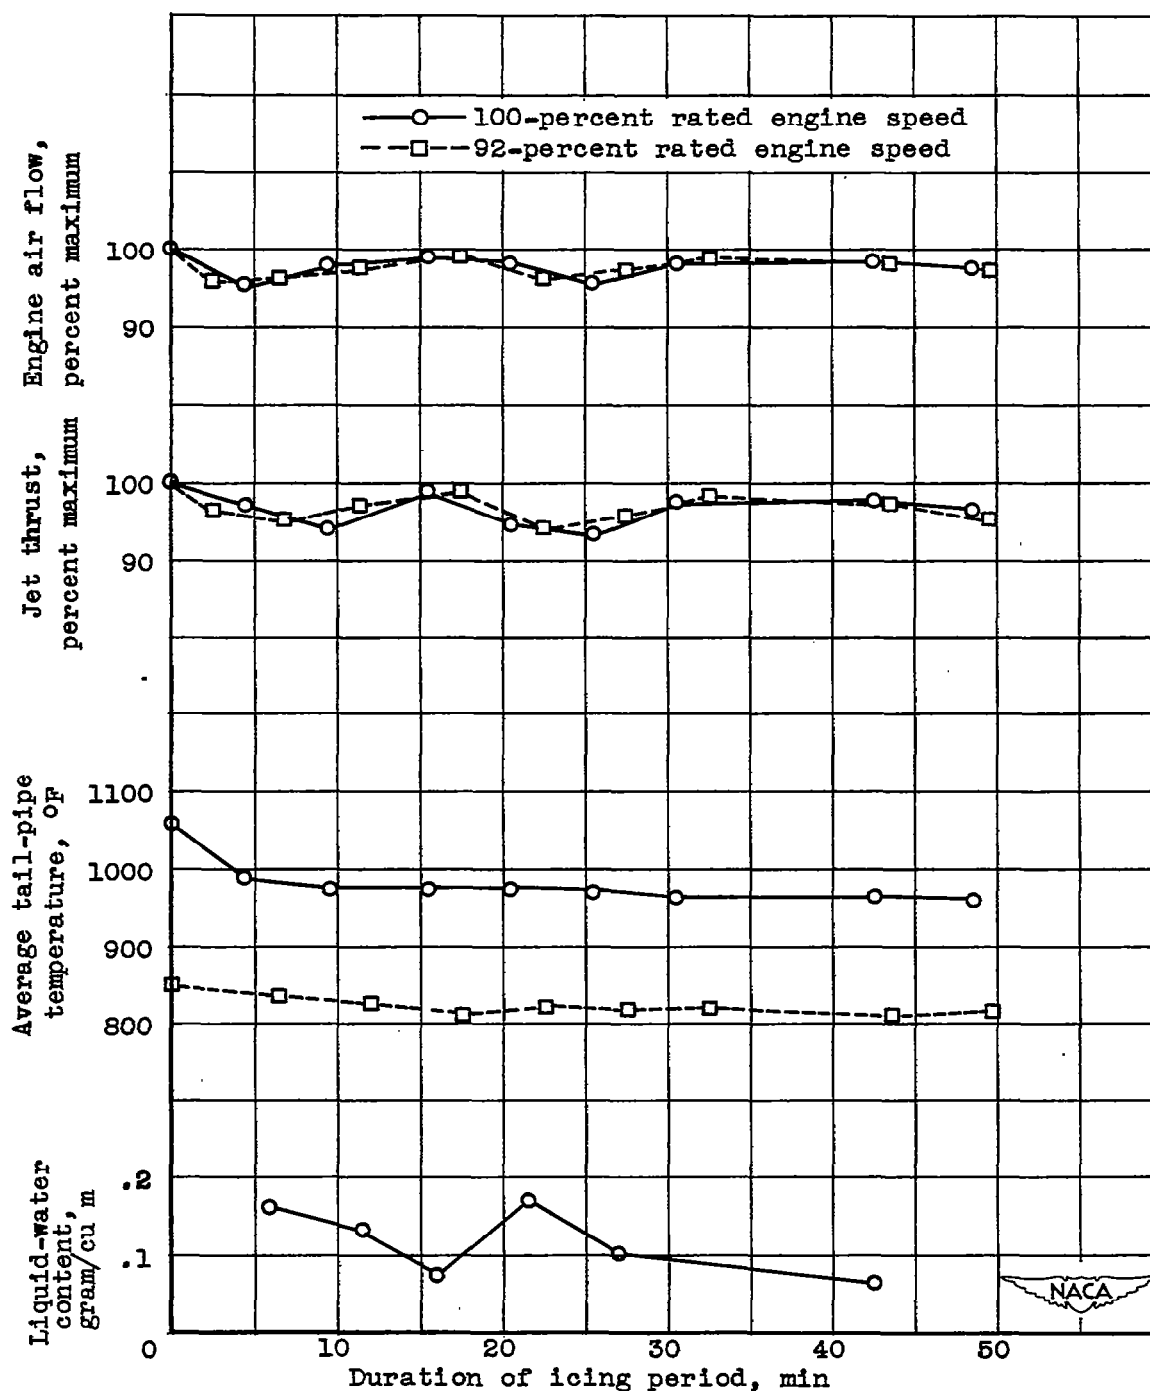
Flight 1 was made in a relatively light icing condition; the liquid-water content varied from approximately 0.1 to 0.2 gram per cubic meter at an ambient-air temperature of 13° to 16° F, with an average water-droplet size of 12 to 27 microns. The resulting ice accretions on the inlet guide vanes caused maximum reductions of approximately 7 and 6 percent in jet thrust and 5 and 4 percent in the engine air flow during a 50-minute operation at 100- and 92-percent rated engine speed, respectively, (fig. 4). The effect of inlet icing on tail-pipe temperature was negligible for both engine speeds.

Figure 4. - Time history of flight data obtained in icing condition during flight 1. Ambient-air temperature, 13° to 16° F; droplet size, 12 to 27 microns; indicated airspeed, 185 to 205 miles per hour; pressure altitude, 3400 to 9300 feet.

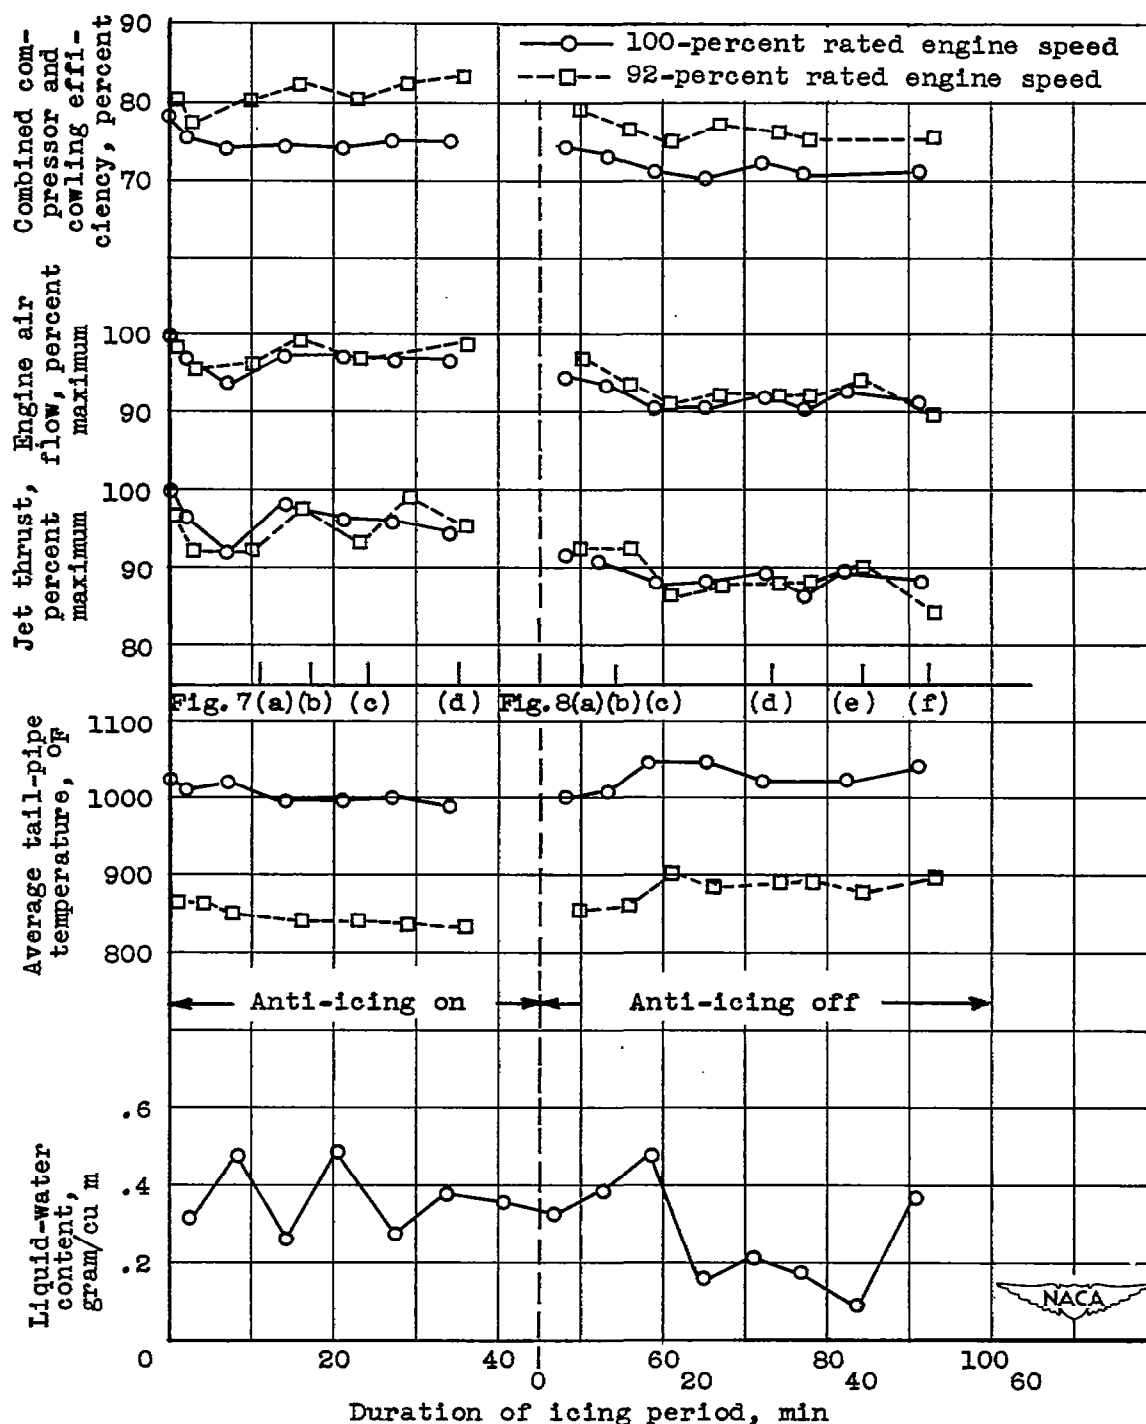
The data obtained from flight 2 are shown in figure 6. In the first part of the flight, during which icing protection was provided for all of the inlet components except the inlet guide vanes, maximum losses of 8 percent in jet thrust, 6 and 4 percent in air flow, and a 4- and 6-percent decrease in compressor efficiency occurred during 45 minutes of operation at 100- and 92-percent rated speed, respectively, because of the restriction imposed by ice on the guide vanes. Increase in engine tail-pipe temperature due to the ice formations was negligible during this period at both engine speeds.

Comparison of the results of the two phases of flight 2 (fig. 6) revealed that ice accretions on the compressor-inlet guide vanes accounted for about one-half the total reduction in engine performance caused by ice on the air inlet. The range of icing conditions remained sufficiently alike throughout the flight to validate this comparison.

Figure 6. - Time history of flight data obtained in icing condition during flight 2. Ambient-air temperature, 22° to 26° F; droplet size, 11 to 20 microns; indicated airspeed, 170 to 180 miles per hour; pressure altitude, 5000 to 6400 feet.

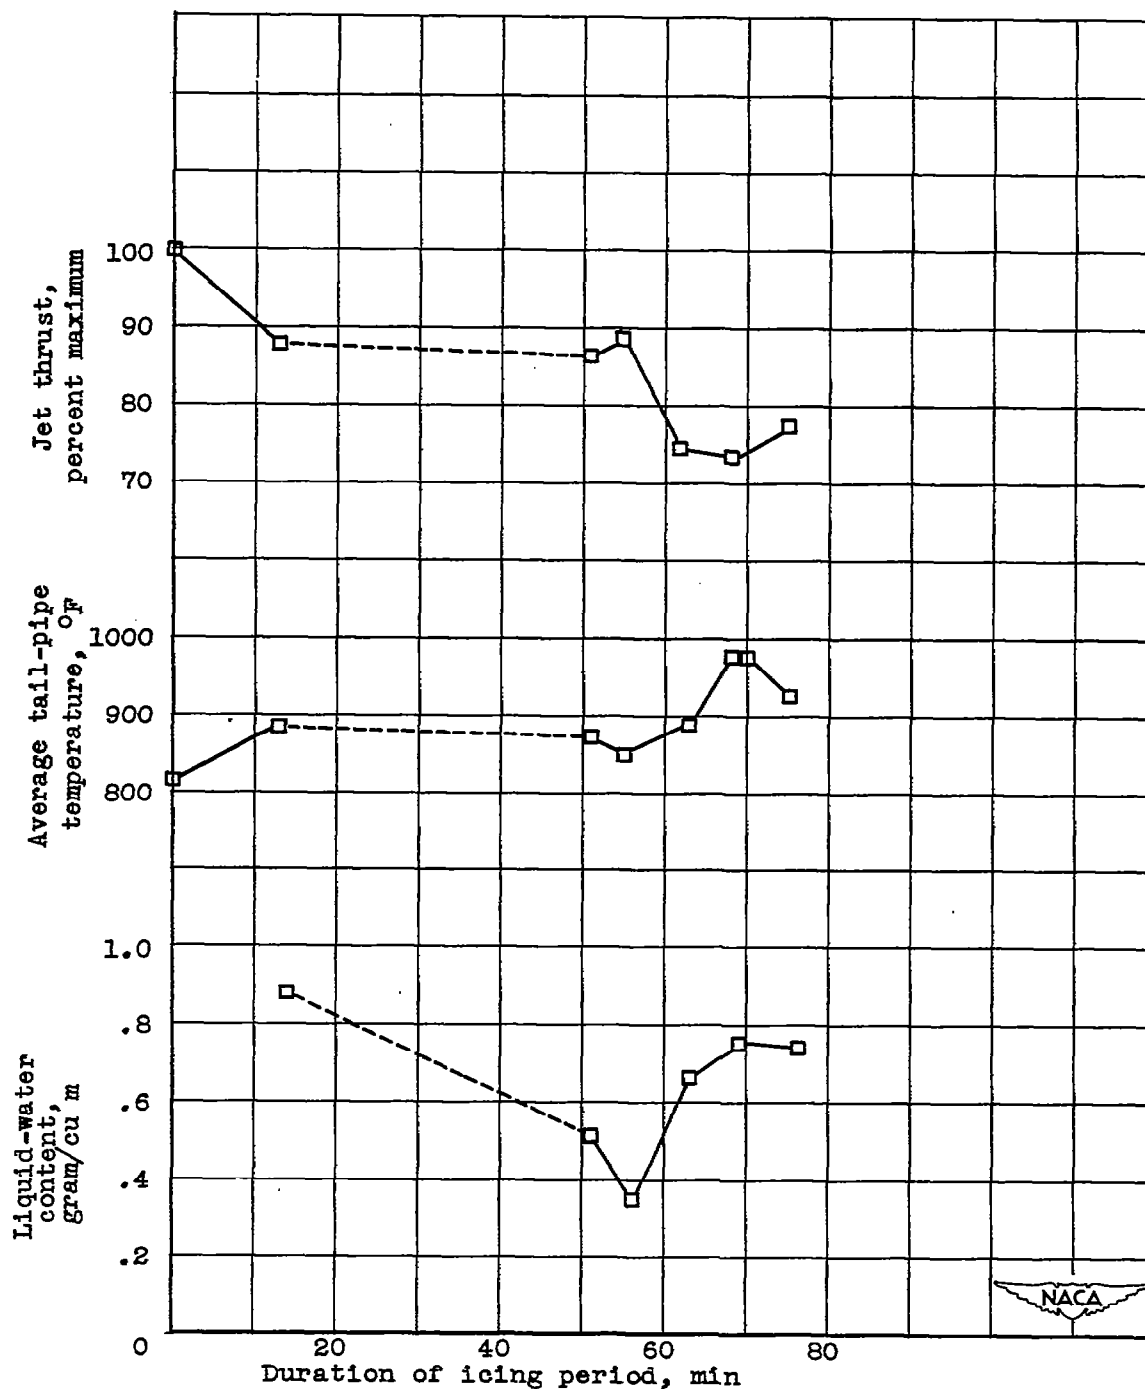
approximately 0.4 to 0.9 gram per cubic meter, which was the highest value of liquid-water content reached during the entire investigation. Water-droplet diameters ranged from 12 to 14 microns and the ambient-air temperature from 17° to 22° F. The resulting ice formations on the engine inlet caused a maximum reduction of 26 percent in thrust and a maximum increase of 160° F in tail-pipe temperature after 70 minutes of operation in the icing condition, as shown in figure 9. Photographs of these ice formations are shown in figure 10. During that part of the flight indicated by the dashed sections of the curves in figure 9, the icing was too intermittent and light to permit reliable measurements.

The reduction in engine thrust and the increase in tail-pipe temperature that occurred during flight 3 are understandable from examination of the large ice accretions on the front-bearing support struts and the large loose pieces lodged on the inlet guide vanes, as shown in figure 10(a). Ice formations can be observed on the first-stage stator blades of the compressor. Further penetration of ice formations in the compressor are not detectable. Soon after the photograph in figure 10(a) was taken, the large ice formations shown began to break up and pass through the engine. A photograph taken 6 minutes later (fig. 10(b)) shows that a large portion of the ice formation had disappeared. The result was an increase in engine thrust and a decrease in tail-pipe temperature of approximately 50° F (fig. 9).

Figure 9. - Time history of flight data obtained in icing condition during flight 3 at 92-percent rated engine speed. Ambient-air temperature, 17° to 22° F; droplet size, 12 to 14 microns; indicated airspeed, 173 to 185 miles per hour; pressure altitude, 4600 to 5900 feet.

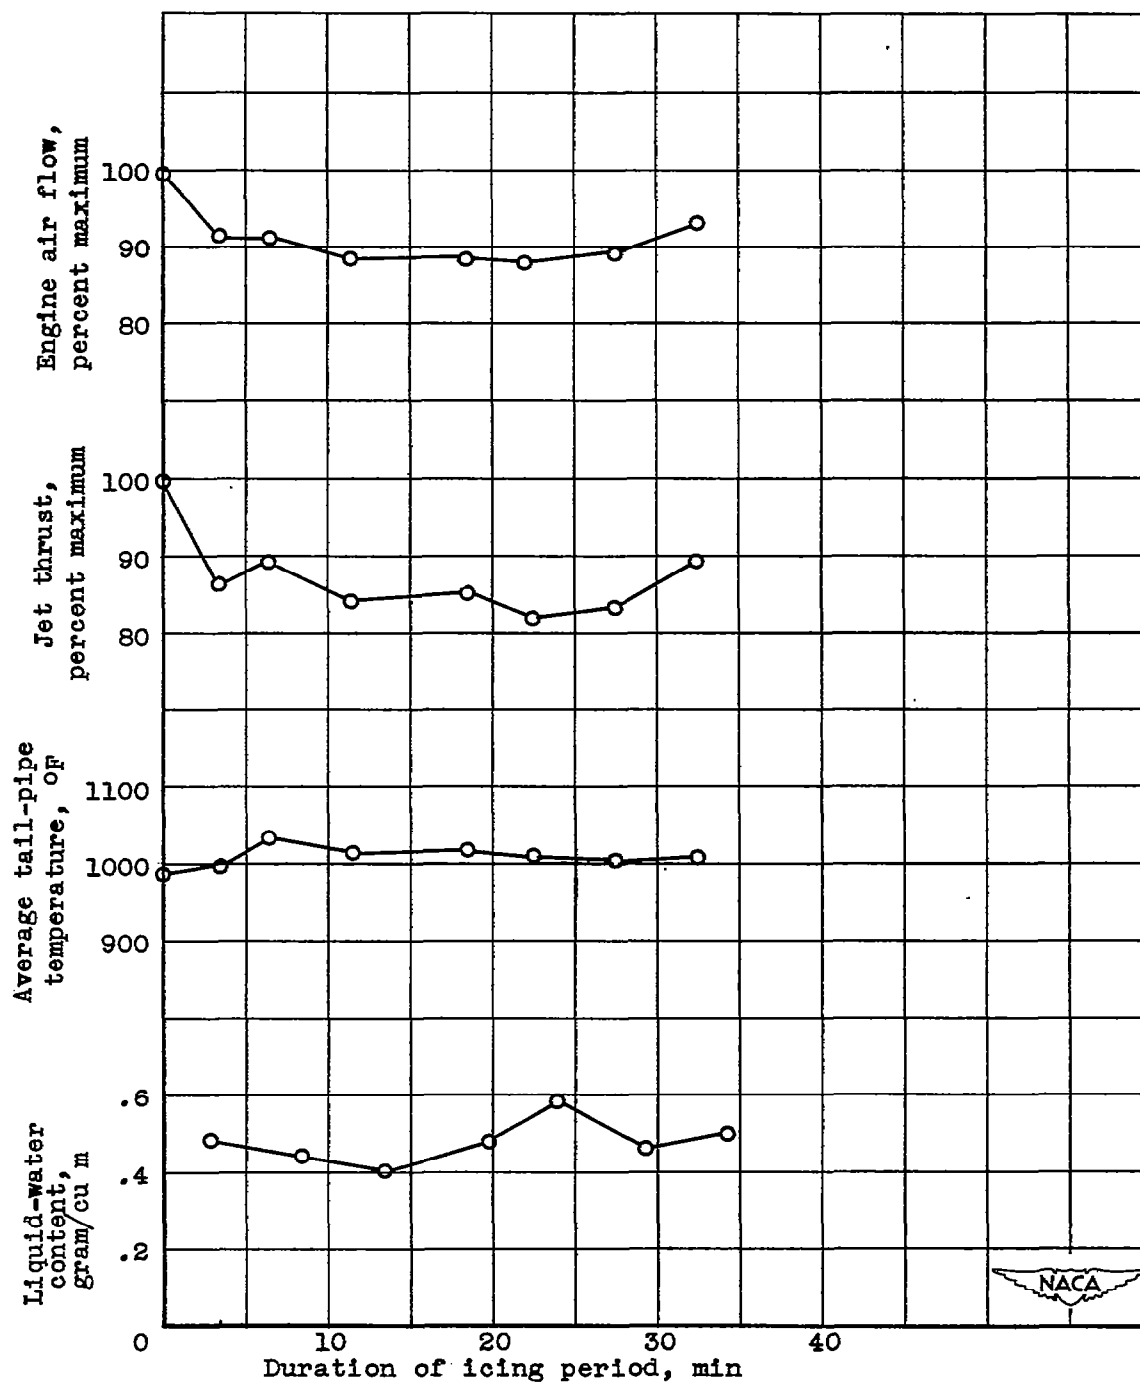
In flight 4, the turbojet engine was operated at rated speed for 35 minutes in an icing condition in which the liquid-water content varied from 0.4 to 0.6 gram per cubic meter, with water-droplet sizes of 11 to 16 microns and an ambient-air temperature of about 25° F. After 22 minutes of operation in this icing condition, the engine thrust was reduced approximately 18 percent, the air flow was decreased by 12 percent, and the tail-pipe temperature was increased 20° F (fig. 11). Within $3\frac{1}{2}$ minutes after entering the icing condition, the engine thrust was reduced 14 percent and the rate of air flow was reduced 9 percent. This rapid rate of reduction in engine performance during the first few minutes of exposure to the icing clouds was attributed to the fact that during this initial period no shedding occurred as in flight 2, which caused a steady growth of the ice formation. Following the initial $3\frac{1}{2}$ -minute period, the process of shedding and rebuilding began and effectively reduced the rate of growth of the ice. The rate of deterioration of engine performance was consequently reduced.

Figure 11. - Time history of flight data obtained in icing condition during flight 4 at rated engine speed. Ambient-air temperature, 25° F; droplet size, 12 to 16 microns; indicated airspeed, 165 to 180 miles per hour; pressure altitude, 2800 to 5000 feet.

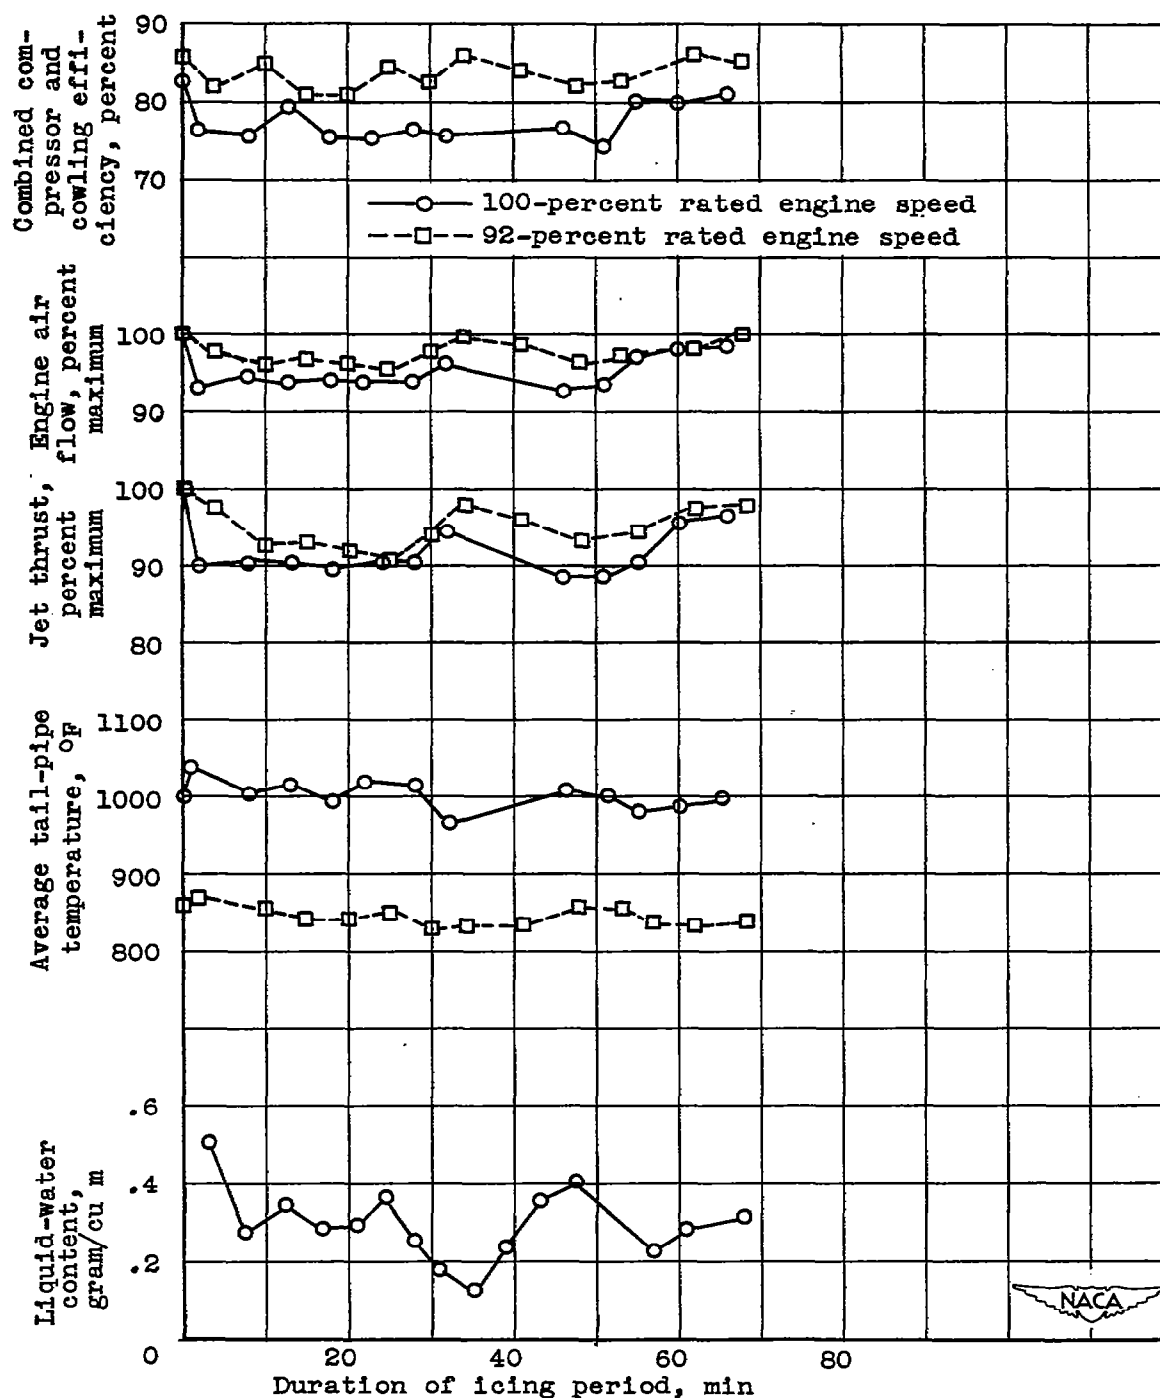
During flight 5, the engine was operated at 100- and 92-percent rated speed for 70 minutes in an icing condition in which the liquid-water content varied from 0.1 to 0.5 gram per cubic meter, with water-droplet sizes of 10 to 18 microns and an ambient-air temperature of 20° to 24° F. Operation in this icing condition resulted in a maximum reduction of 12 and 9 percent in engine thrust, 7 and 5 percent in air flow, 9 and 5 percent in compressor efficiency, and tail-pipe temperature was increased a maximum of 40° and 10° F at 100- and 92-percent rated speed, respectively, (fig. 13). Within the first minute in the icing encounter, the engine thrust at rated speed was reduced approximately 10 percent and the tail-pipe temperature increased 40° F. The initial losses were equivalent to the maximum losses reached during the entire 70-minute flight, thus illustrating again that the steady growth of the ice formation during the first few minutes of exposure to icing caused the greatest rate of reduction in engine performance. A photograph taken after approximately 23 minutes of operation in this icing condition (fig. 14) shows the typical ice formations obtained during the encounter.

Figure 13. - Time history of flight data obtained in icing condition during flight 5. Ambient-air temperature, 20° to 24° F; droplet size, 10 to 18 microns; indicated airspeed, 175 to 180 miles per hour; pressure altitude, 4200 to 4500 feet.
